# **Wattle and Daub: Craft, Conservation and Wiltshire Case Study**

**A dissertation submitted by**

**Tony Graham**

**towards the degree of Master of Science in the Conservation  
of Historic Buildings at the University of Bath.**

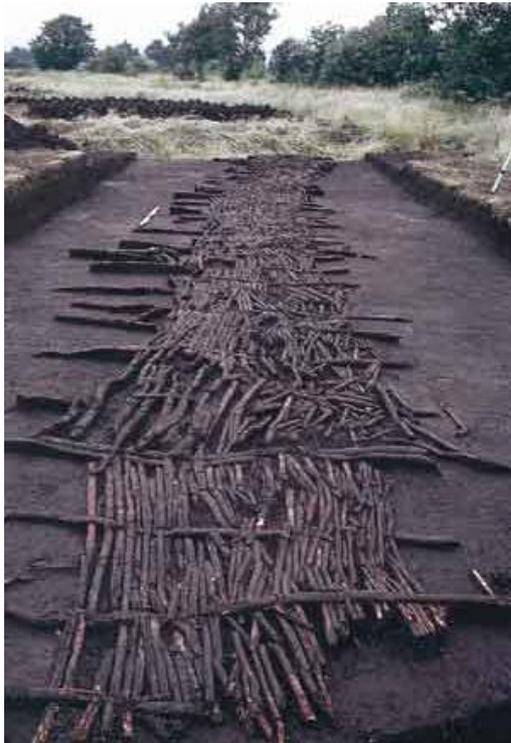
Figure 1. Iron Age wattle used flat as a track, c.1800 B.C. From Brunning (2001).

The origins of wattle and daub stem from the primitive buildings, where huts were constructed of poles and earthen walls. Archaeology shows the techniques were numerous and their boundaries ill-defined. Earth walling could be used simply as a base for a roof, or higher walls could be formed to raise the roof away from the ground. The walls could be made with wattles, woven from brushwood or 'withies' (thin wands) coppiced from nearby woodlands. These wattle walls, bearing no significant difference to the construction of hurdles, used the same technique as fencing for boundaries, penning, wind-resistance and privacy and those laid flat as tracks [Figure 1].

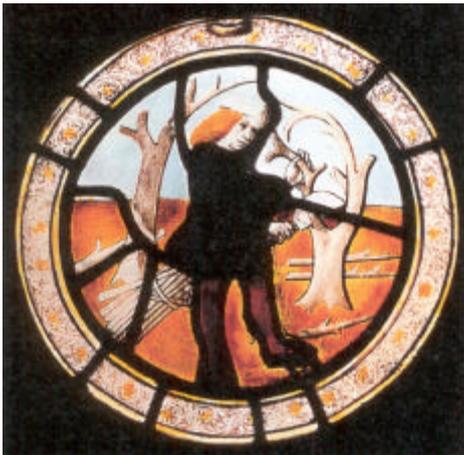
Figure 3. 'Lopping and topping' from coppice woods. 15<sup>th</sup> Century. From Nicholson and Fawcett (1988).

In primitive and peasant building the wattle and daub work would have been done by the house owner.<sup>12</sup> The peasant would construct his home from slender timbers and use the early customary right to 'lopping and topping' to provide wood, often oak or ash, for wattling [Figure 3]. From the 11<sup>th</sup> century, managed coppicing would secure a supplier of these underwoods. This may have been daubed with earth, straw and dung. Chalk or lime may have been added where available. For wealthier owners, the work may have been done by a dauber (torcher), the workmen often referred to as 'dauratores' or 'dealbatores'.<sup>13</sup> The position of the dauber within the crafts was well established, as illustrated as early as 1212 in a list of maximum daily wages,<sup>14</sup>

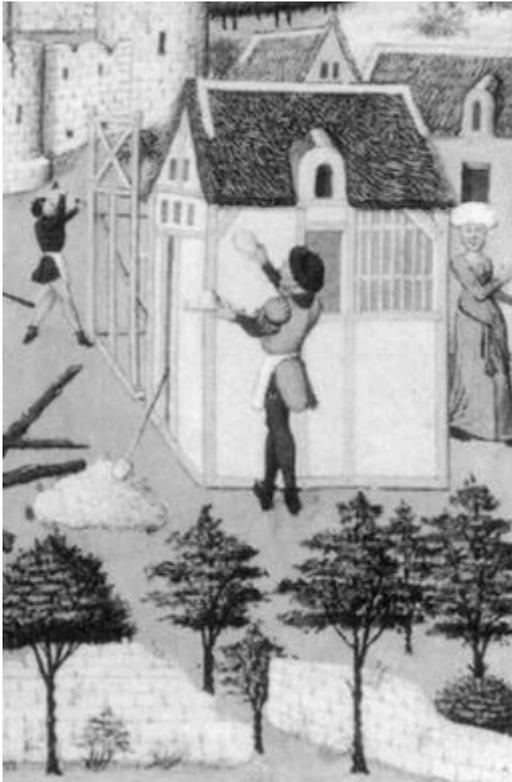
Figure 4. A 15<sup>th</sup> century artisan plasterer completing infill panels after the carpenter had finished his work. From Binding (2001).

This also shows that whilst considered skilled craftsmen, the plasterers and daubers were less well regarded than the carpenters and masons who may have designed the house as well as constructed it [Figure 4].

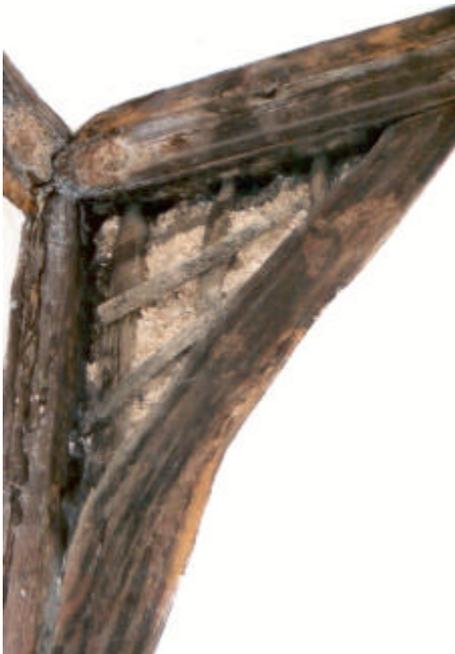
Figure 6. Complexity of wattlework in arch-brace panel was avoided here by nailing three laths diagonally onto the staves (top-most lath is missing).

sample size by seeking out additional examples becomes increasingly poor. However, on the positive side, it is because of this diversity of methods and materials that it is still common to find new variations when investigating infill panels in historic buildings [Figure 6 and Figure 7].

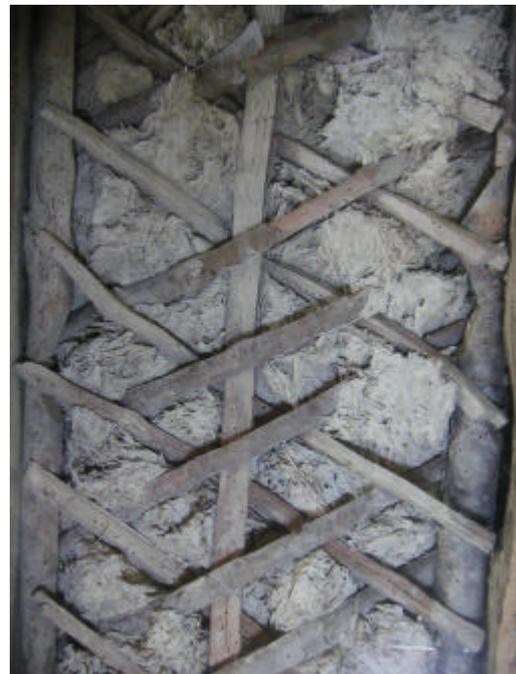
Figure 7. A lattice formed by weaving withies diagonally. South Cambridgeshire, c.1700 (Courtesy G. Murfitt).

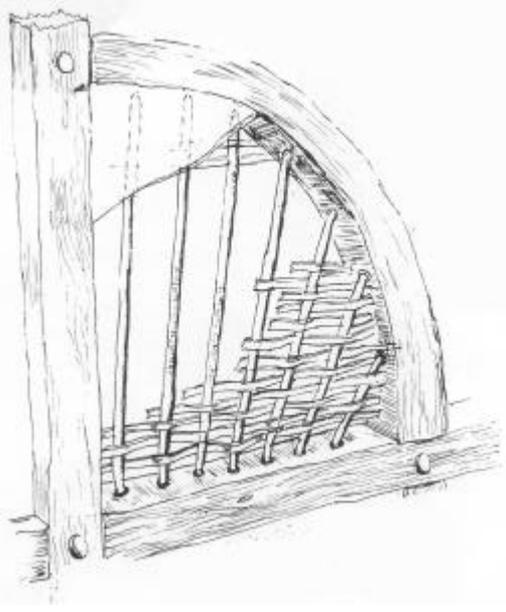
Figure 11. Configuration of staves and wattle in a braced panel. From Reid (1989).

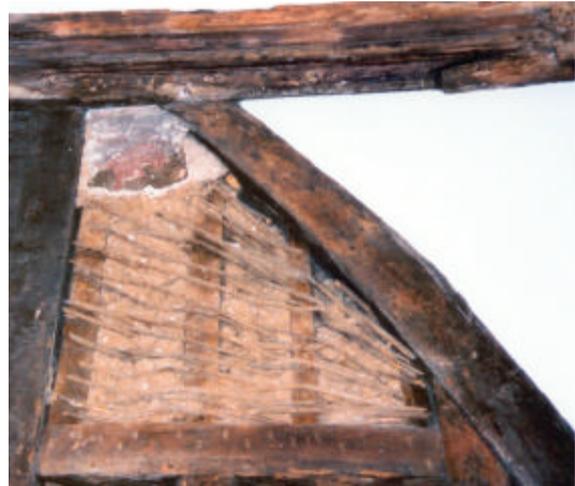
Figure 12. A braced panel watted by altering the angle of the withies.

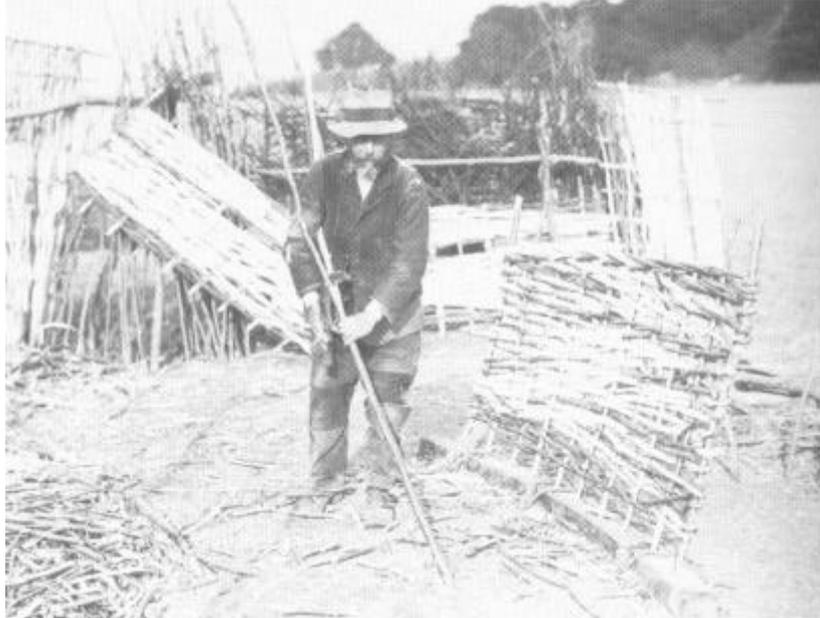
Figure 15. Wattle fencing in Hampshire, as used by sheep farmers. From Edlin (1949).

The supply of withies from coppice woods was often in the form of underwood that shared space with timber trees. Managed coppicing was well established by the middle ages, especially in areas of intensive sheep farming such as Hampshire, Wiltshire, West Sussex and Dorset where hurdles were used as fencing [Figure 15].<sup>31</sup> Whilst it is generally accepted that large timbers may have been transported significant distances for the construction of the more substantial house, coppice wood may also have been transported to supply

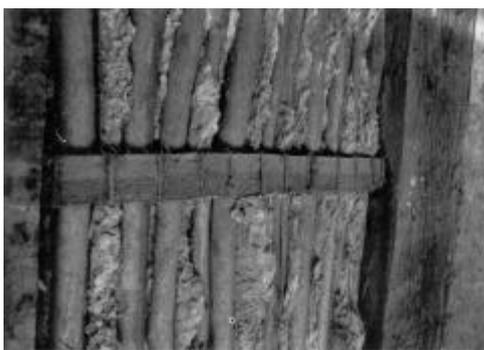
Figure 18. Evidence of string used to tie withies. From Rackham (1976).

Lath was riven using a drawknife or a lath-maker's froe, also known as a lath axe [Figure 17]. Where laths were secured by nailing, a gap was required between adjacent laths to provide a key for the daub. However, when woven, they would be packed tight against each other, as were the withies, since gaps would be created naturally within the weave thickness. Clifton-Taylor (1962) suggests that laths were *always* nailed yet Rackham has observed the bast fibres (phloem) from lime used as string.<sup>35</sup> Thompson (2003) suggests that both nails and string may have been used to secure laths to the staves.<sup>36</sup> Contradictorily, Wright (1991) says the presence of nails, string or wire indicate later repairs, but evidence of tying both laths and withies suggests otherwise [Figure 18].

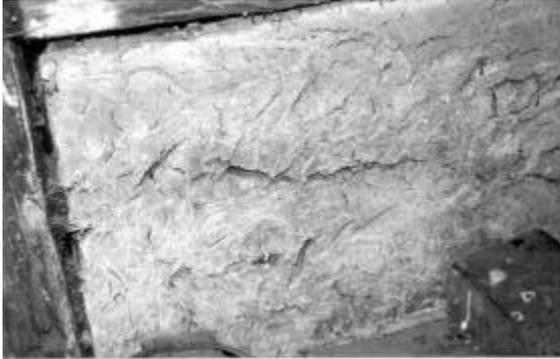
Figure 19. The daub of sheltered internal partitions was often crudely finished, with cracking left unattended.

Where the work was hidden and was not to be exposed to the weather, such as in roof truss partitions, the evidence of large cracks suggest the dauber readily accepted the crude finish and did little to rework the panels [Figure 19].

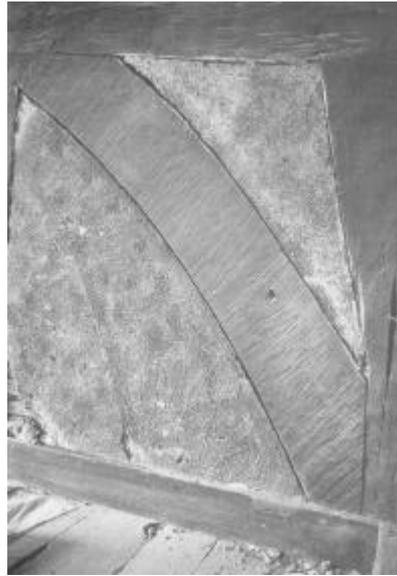
Figure 21. Medieval daub decorated with combed pattern, Sussex. From Warren (1999).

Panels may have been given interest by lightly combing the finished surface prior to limewashing [Figure 21]. From the 16<sup>th</sup> century, external walls were frequently decorated with incised patterning, a rudimentary form of pargetting also known as 'stick-work' or 'combed work'. The patterns would have been formed by crude wooden combs, a stick or large nail [Figure 22].<sup>47</sup> Gypsum was used for plasterwork where available, such as the Isle of Purbeck, around Knaresborough in Yorkshire and the Trent Valley. Since its properties were conducive to modelling ('raised' work), it is not surprising that ornamented pargetting was developed. It became particularly fashionable from the 16<sup>th</sup> century and into the 17<sup>th</sup> century, especially in East Anglia where the whole frame would be covered and intricately decorated. [Figure 23].<sup>48</sup>

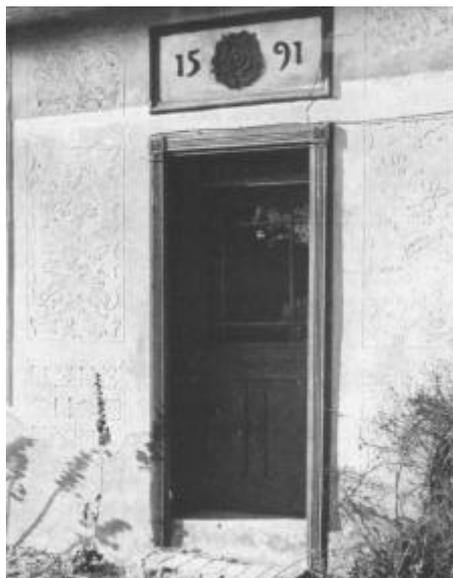
Figure 22. Incised pargetting, Suffolk. From Clifton-Taylor (1962).

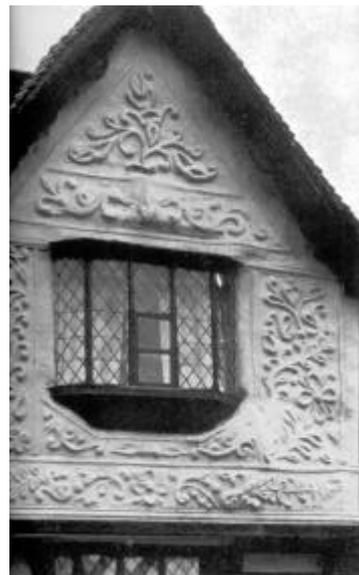
Figure 23. Raised pargetting. The Ancient house, Clare, Suffolk. From Clifton-Taylor (1962).

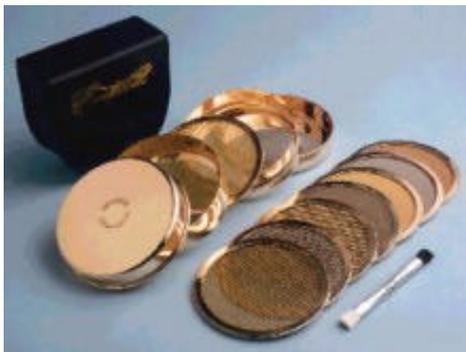
Figure 28. Compact packet sieves for field use. (Courtesy of Endecotts Ltd)

The proportion of fines can be judged by spreading a sample and inspecting with a loupe magnifier. A more detailed field test can be done using a set of 'pocket sieves'. Similar to their larger counterparts used in the laboratory, they can quickly grade the gravels, sands and silts of a small soil sample on-site [Figure 28].

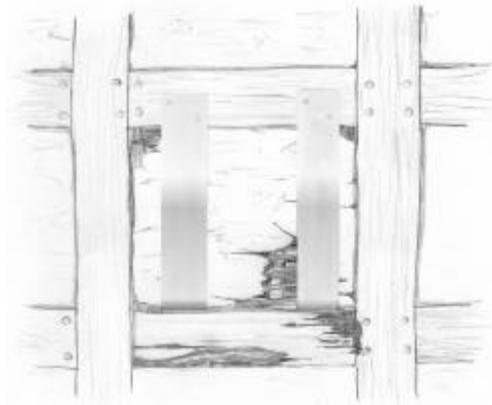
Figure 30. Removal of bottom rail for repair by providing temporary vertical support for wattle. L-shaped metal sheets are pushed inwards between bottom of wattle and frame and screwed to upper rail.

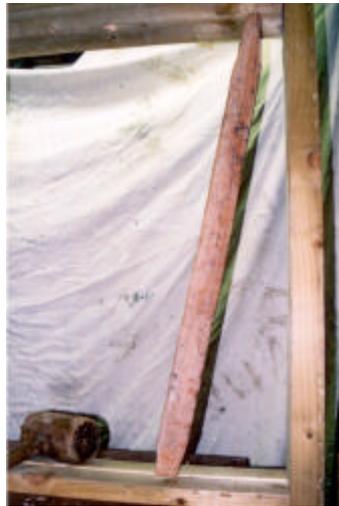
Figure 34. Insertion of a stave into a test panel.

1. Prepare staves by splitting heartwood of oak using a froe.
2. Sharpen tops to fit stave holes.
3. Bevel the bases to fit the groove.
4. Insert staves by sliding base sideways [Figure 34].
5. To provide the withies, coppice and split sufficient hazel rods, preferably during winter when there is less sap.
6. Ensure correct length by weaving a reference withy. Prepare remaining withies by cutting to same length as the reference.
7. Narrow the ends if fitting into stud grooves.
8. Weave withies, alternating the side of the staves with each row [Figure 35].<sup>101</sup>
9. Tamp down withies to base of panel to make compact.
10. Complete insertion of withies up to the top of the panel.
11. Leave the panel to season. Tamp down and add additional withies to fill any resulting gap at the top.

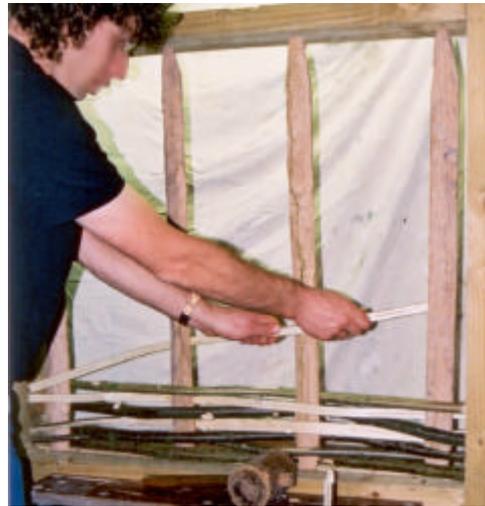
Figure 35. Weaving of withies.

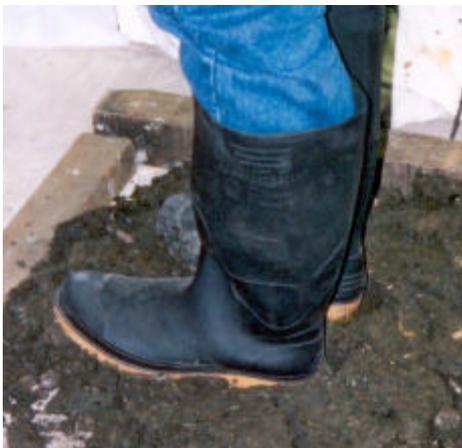
Figure 36. Mixing of daub by 'heeling'.

1. Place the earth into the mixing frame.
2. Pick out any coarse gravel.
3. Add additional aggregate or clay, as necessary, distributed evenly across the surface.
4. Mix thoroughly by 'treading' with the heel of the boot [Figure 36]. When compacted, the daub should be lifted and turned using a shovel or 'cob-pick'. Continue treading and turning.
5. Inspect the daub at regular intervals during treading: the result should be a well-mixed 'sandy clay'.
6. A little water may be required to permit the clay to coat the aggregate and to make the daub workable, but the daub must be kept as dry as possible.
7. Add cow dung and mix by treading. Add only sufficient dung to make the daub feel plastic.
8. Fibre, such as hair, chopped straw or hay is scattered evenly onto the earth.
9. Further treading and to complete the mixing [Figure 37].

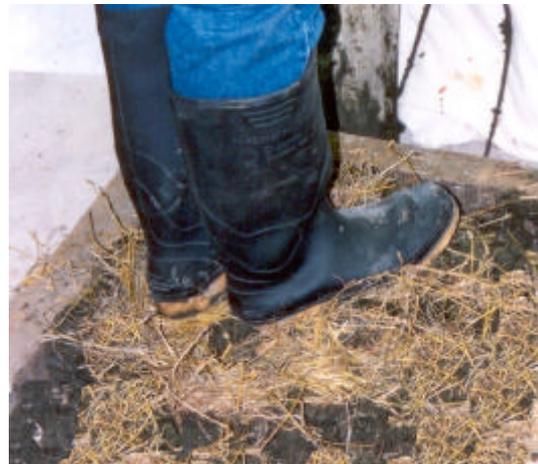
Figure 37. Treading straw into daub.

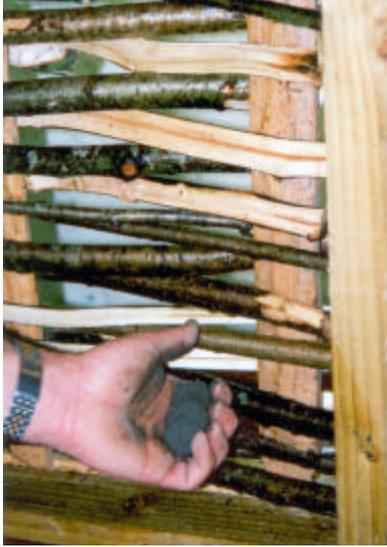
Figure 38. Knocking up a cat in the hand.

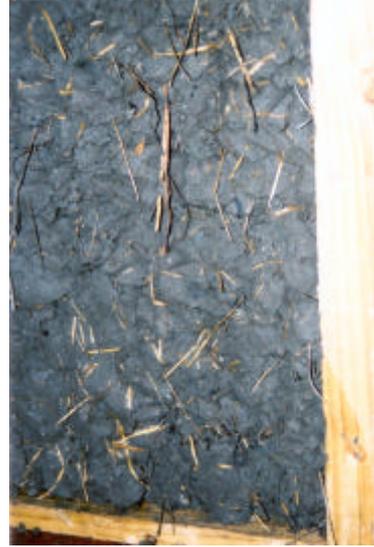
Figure 39. Cats form a homogenous daub.

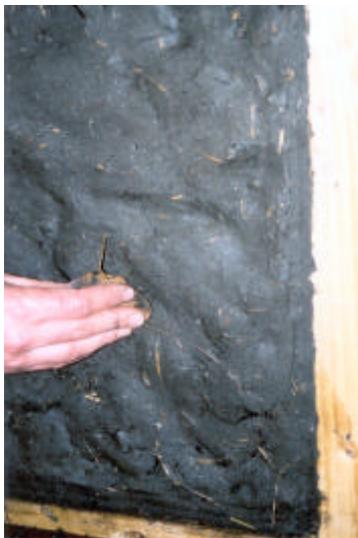
Figure 40. Consolidating the daub surface and edges of cats using a damped pad

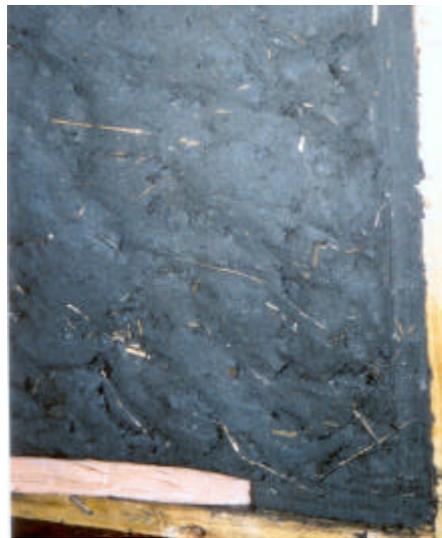
Figure 41. Using a piece of lath to bring the daub up against the frame edges.

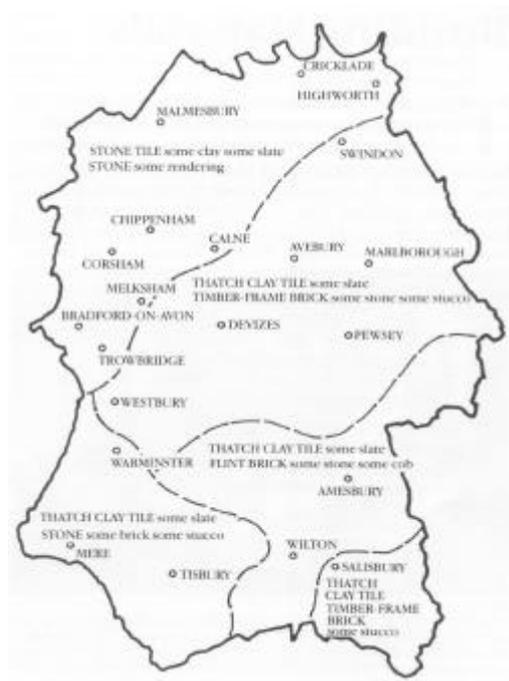
Figure 45. Predominant building materials of Wiltshire. From Slocombe (1989).

Much rebuilding in stone occurred in the county, with vast quantities of limestone used in the north and west, chalk 'clunch' in the south and brick refacing throughout the county [Figure 45]. These materials often disguise timber framing, making it difficult to predict where wattle and daub might be found. Surviving structural frames exist throughout the county, although the majority are clustered in areas where stone was not initially available, such as to the east in the Pewsey Vale and the towns of Marlborough and Devizes. The medieval City of Salisbury also has a large number of surviving frames. This information was used to ensure fieldwork covered all main geological areas of the county.

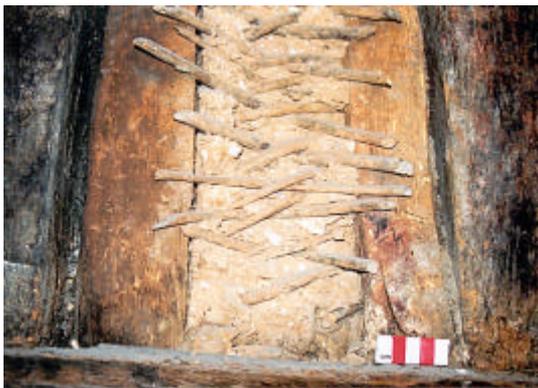
Figure 49. Wattle tensioned in a narrow two-stave panel by entwining pairs of withies.

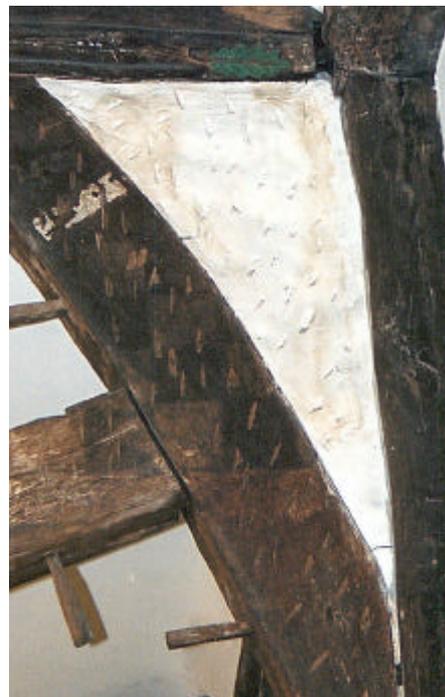
Figure 50. Sparrow-pricking to an internal panel. (The pegs in adjacent panels were to provide a key for plaster block work, now removed.)

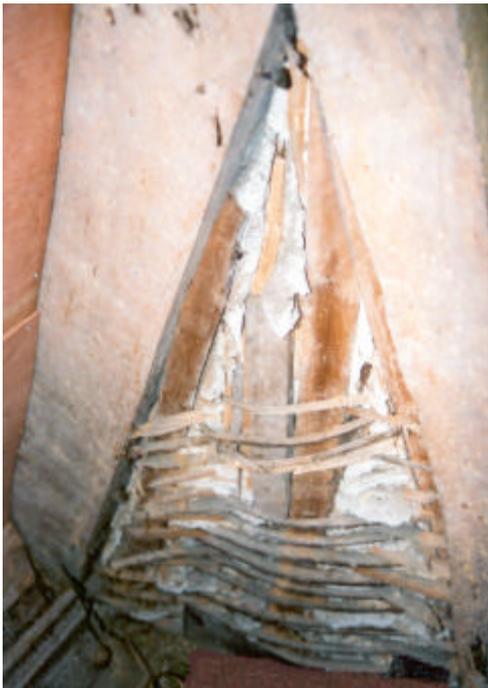
Figure 51. Outer staves nailed against soffit of frame.

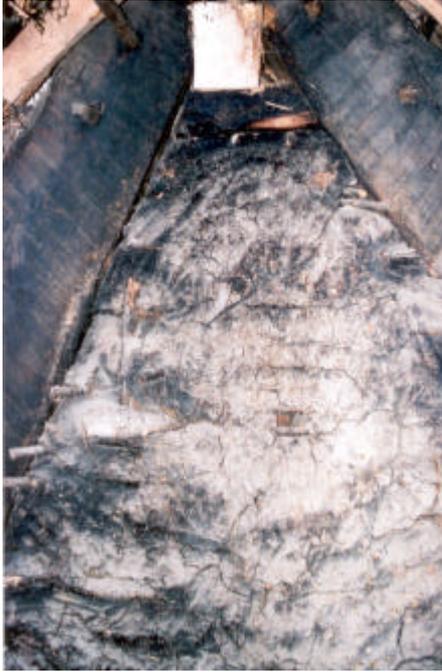
Figure 52. Smoke-blackened wattle and daub at apex of cruck.

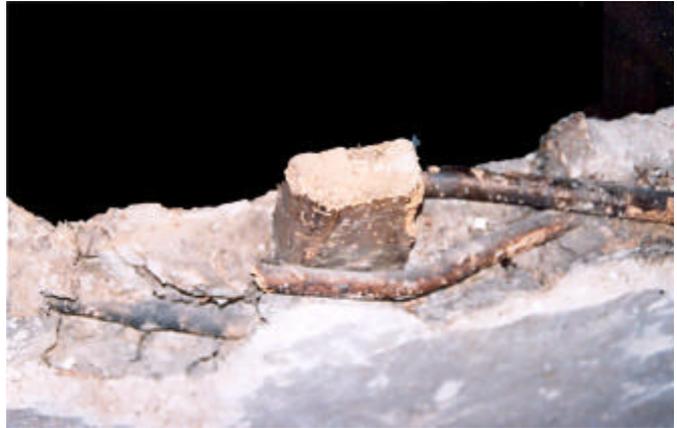
Figure 53. Cross-section of a stave. Other evidence indicated this was intentionally chamfered rather than representing the wavy edge of the riven timber.

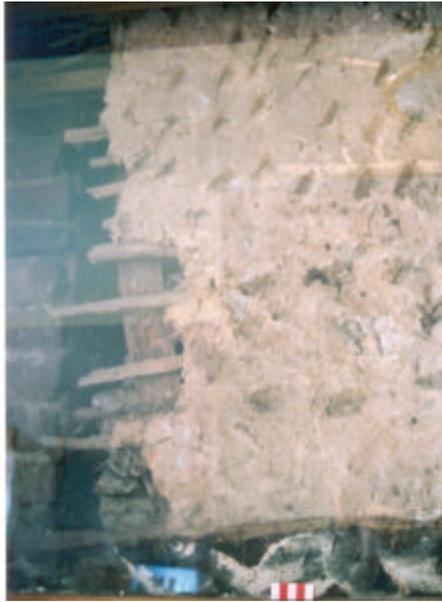
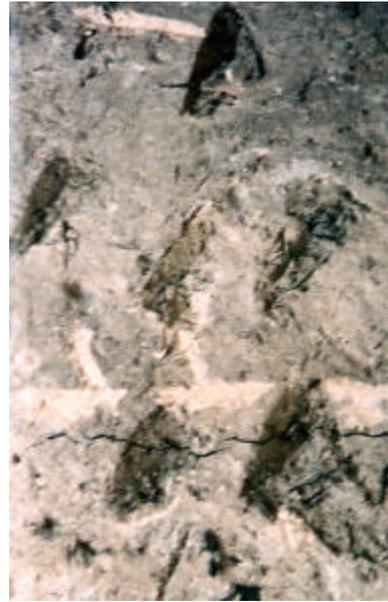
(a)

(b)

Figure 54. Wattle of whole and split withy (a) and enlargement of sparrow-pricking (b).

The house, previously a farmhouse, is cruck-framed and dates from c.1450 with later alterations. A central truss was found to have been closed with wattle and daub between the blades down to tie-beam level. Only a small area was plastered, possibly an indication of a repair. The remainder of the partition was roughly finished with daub and, since it was heavily smoke-blackened, may have formed part of the original construction [Figure 52]. The wattle was of whole hazel withies woven around long staves running the full length between blade and tie-beam. In places, these had been roughly chamfered, which was most visible where staves had been cut to enable access along the roof space [Figure 53].

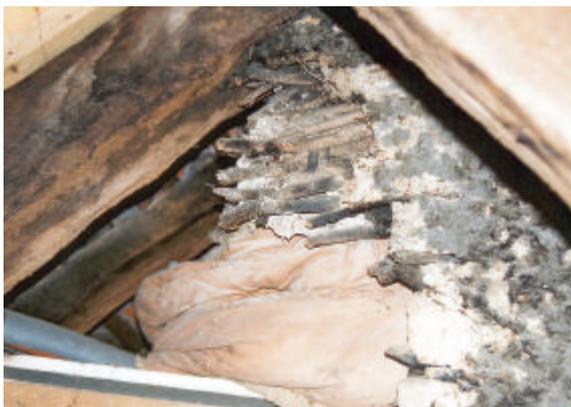
Figure 55. Staves attached to soffit of principals, whole withies and smoke-blackened daub, c.1480.
